Conservation and Restoration of Angkor Wat and Ta Prohm Temple, Siem Reap, Cambodia

Devender S. Sood

Conservation and Restoration of Ta Prohm Temple, Siem Reap, Cambodia

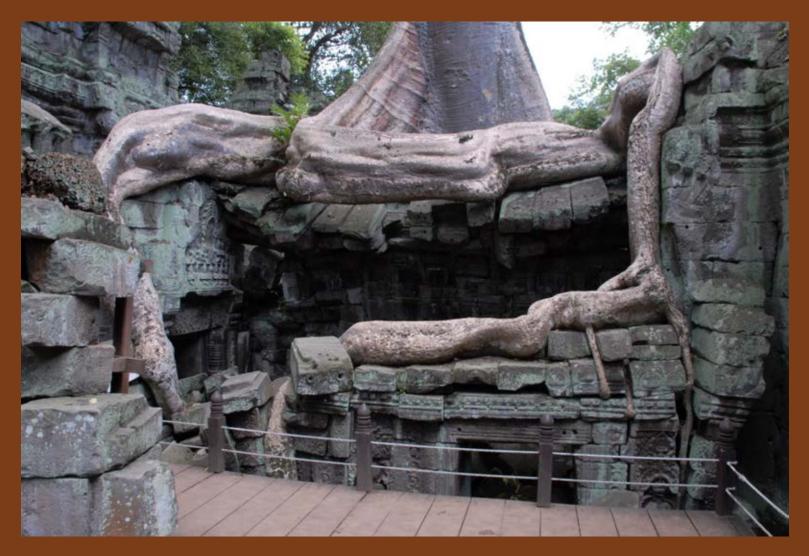
The Entwining Tree Roots, TA- PROHM, TEMPLE

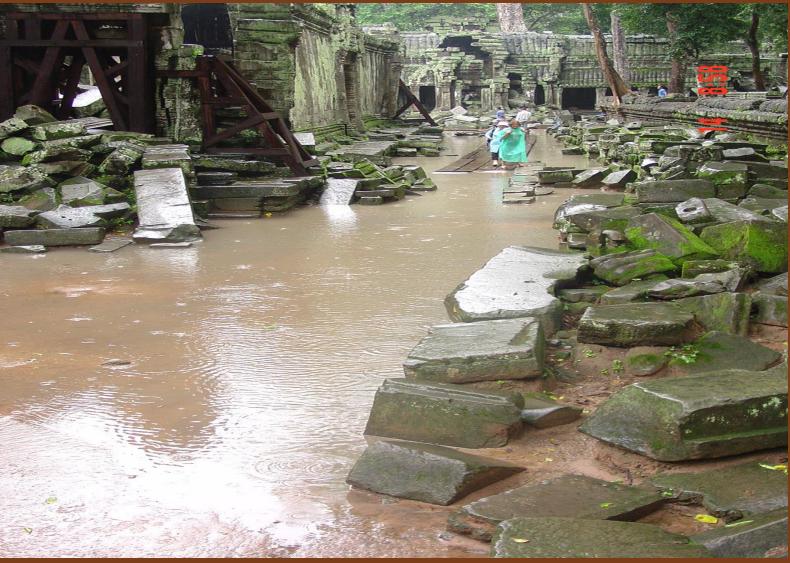
Stagnated Water in TA-PROHM, TEMPLE

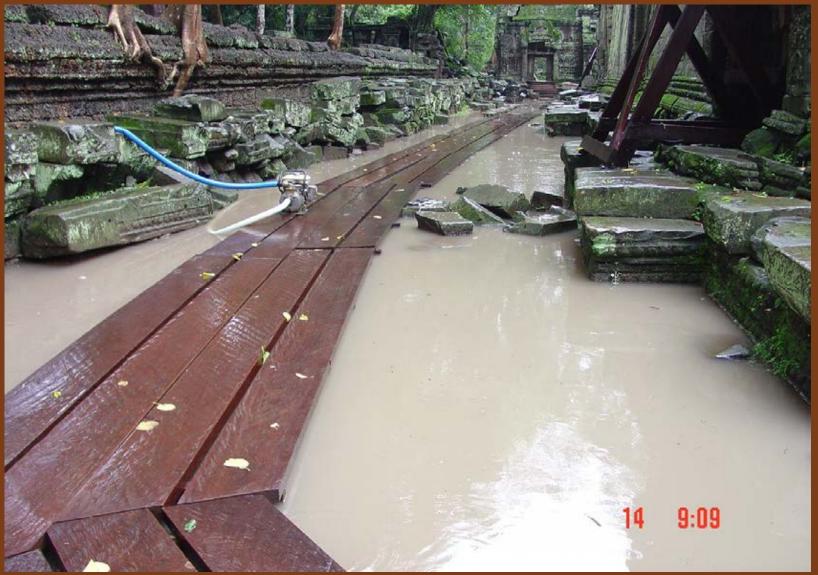
Stagnated Water in TA-PROHM, TEMPLE

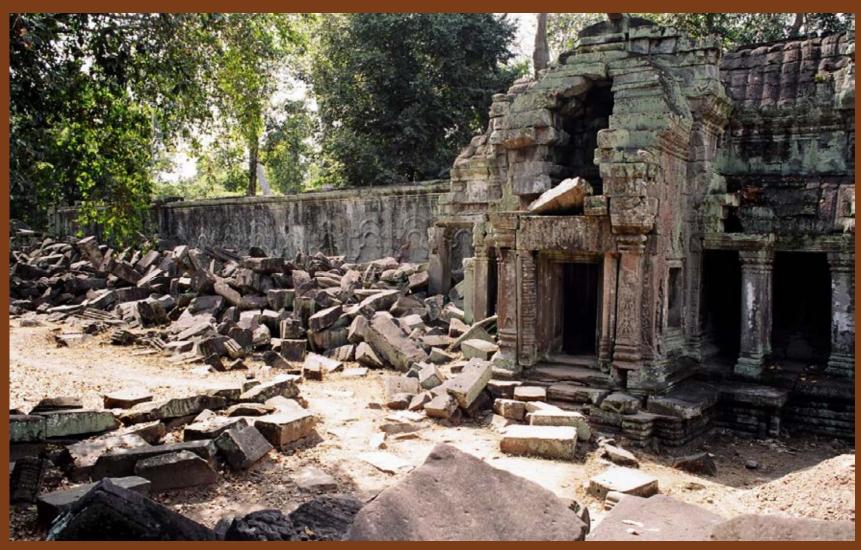
Collapsed third Enclosures Gallery on South East, Ta- Prohm, Temple

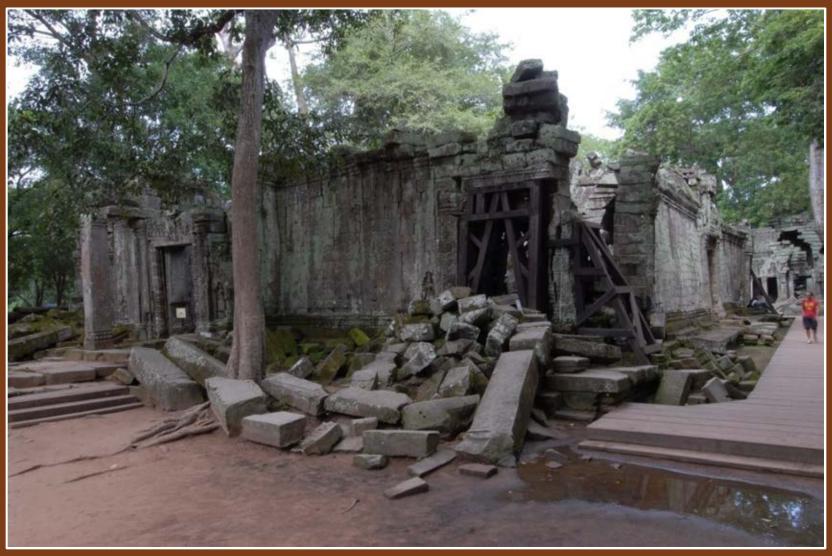
North-east corner before dismantling inclined wall and removing fallen stones

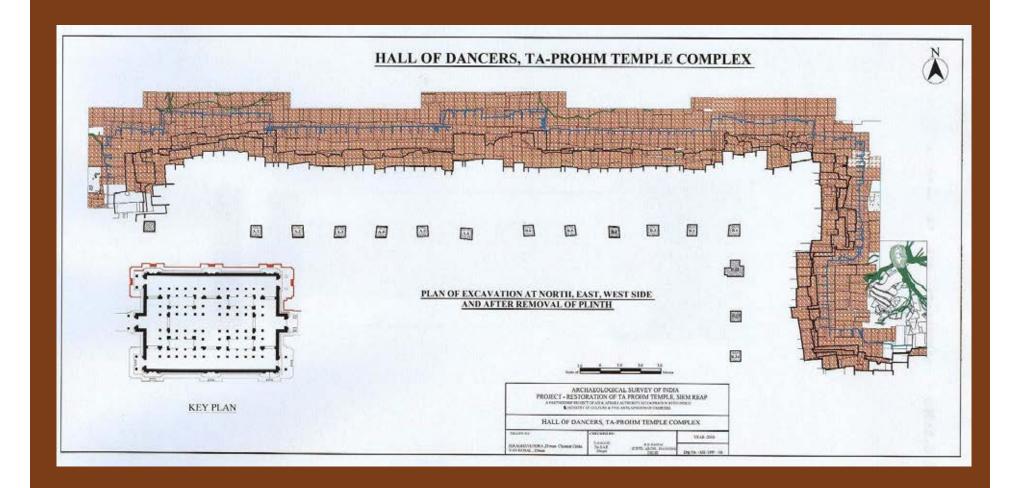
Hall of Dancers - Exposed laterite apron along the north east plinth.

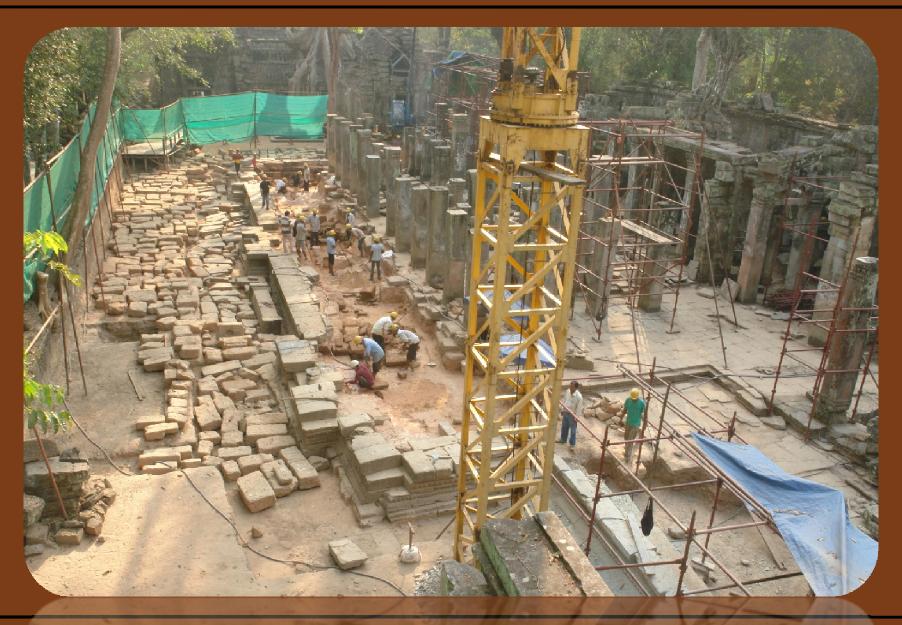
Hall of Dancers - Inter northern floor after removal of sandstones and laterite stones.

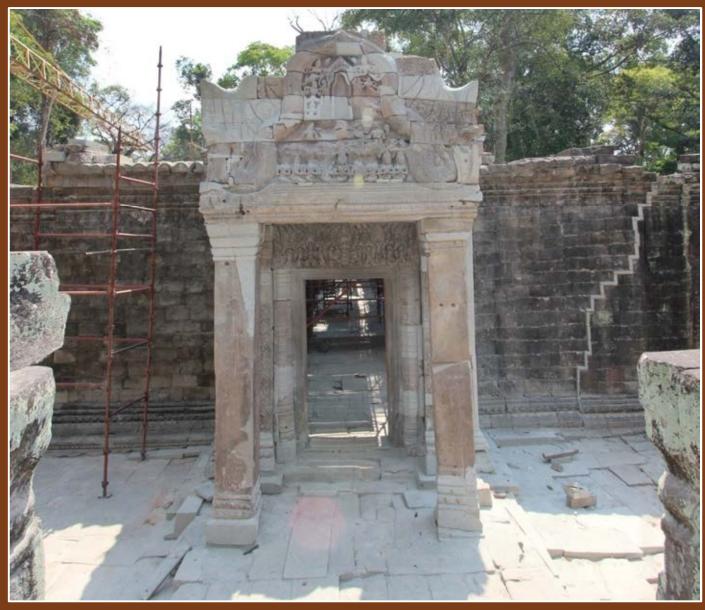
South-west Corner (Discernible distinction - original and restored portions)
