ARCHAEOLOGIA

VOLUME C

The Fussell's Lodge Long Barrow Excavations 1957

By PAUL ASHBEE, Esq., M.A., F.S.A.

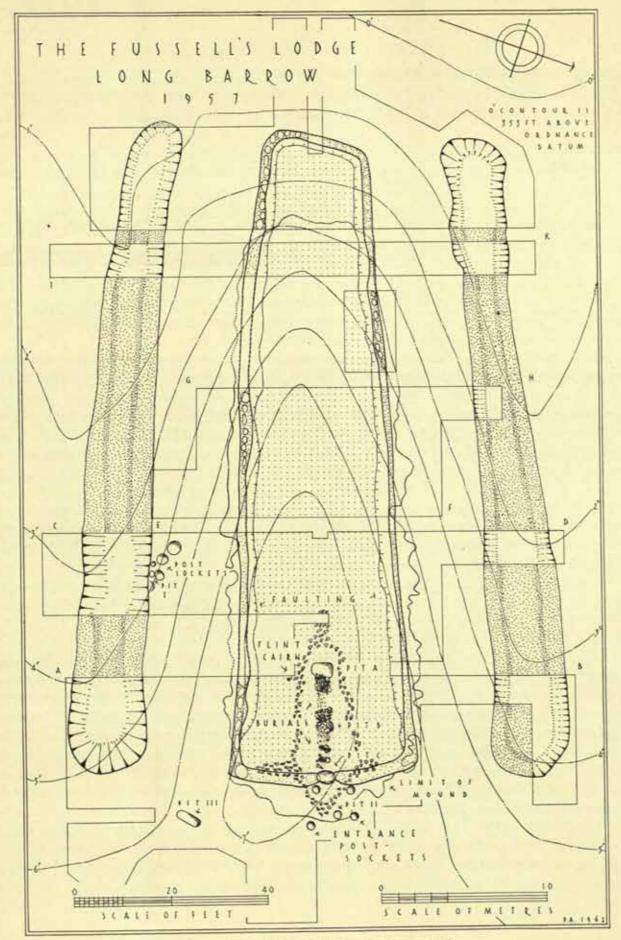
Fig. 2. General plan of the barrow as excavated

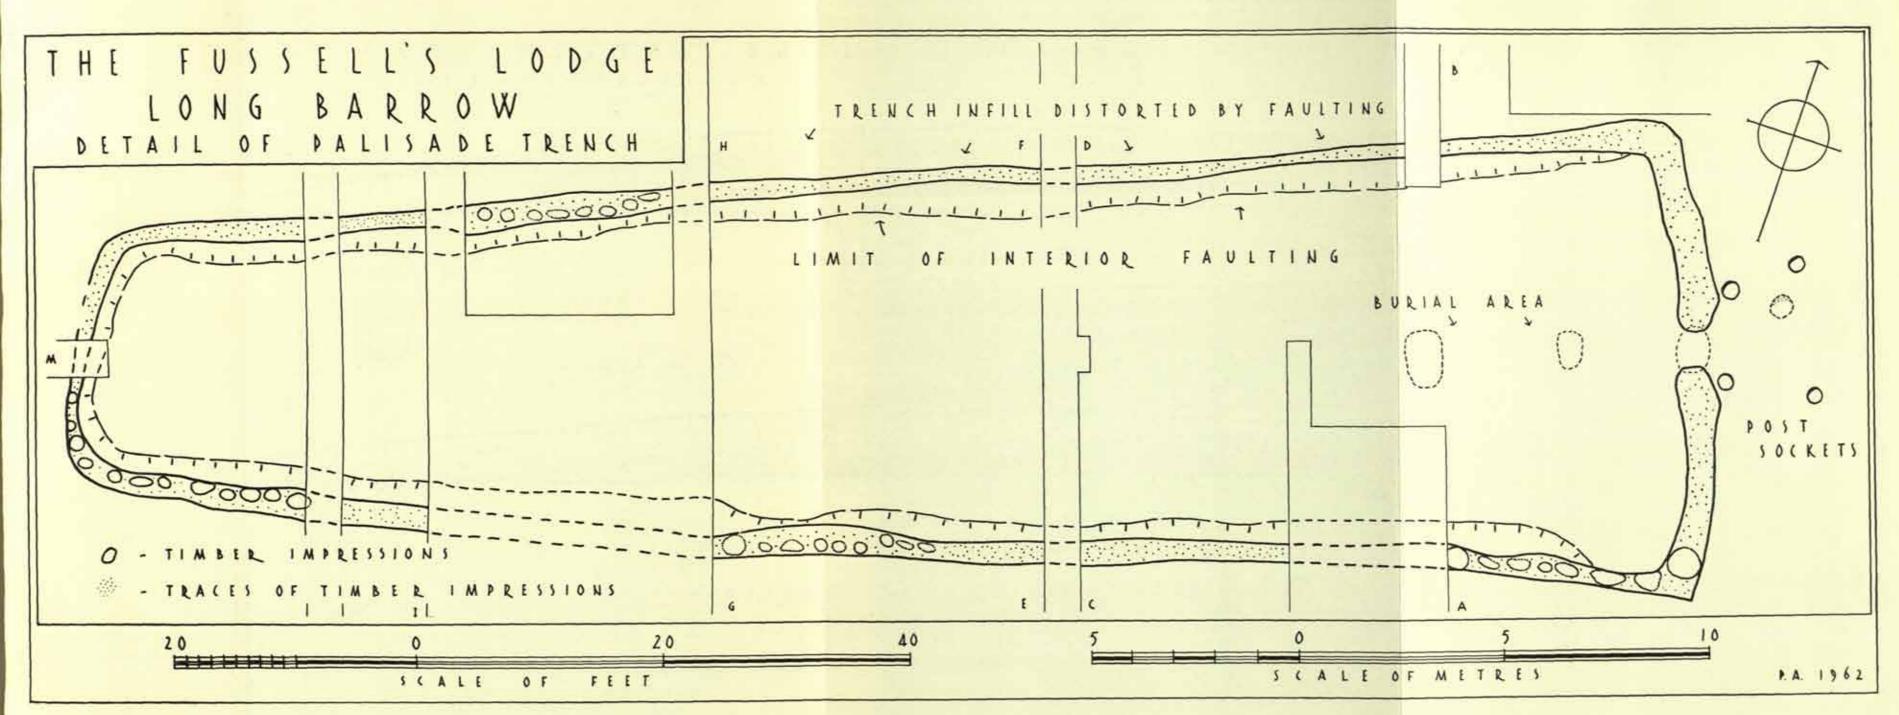
Plan of the Palisade Trench

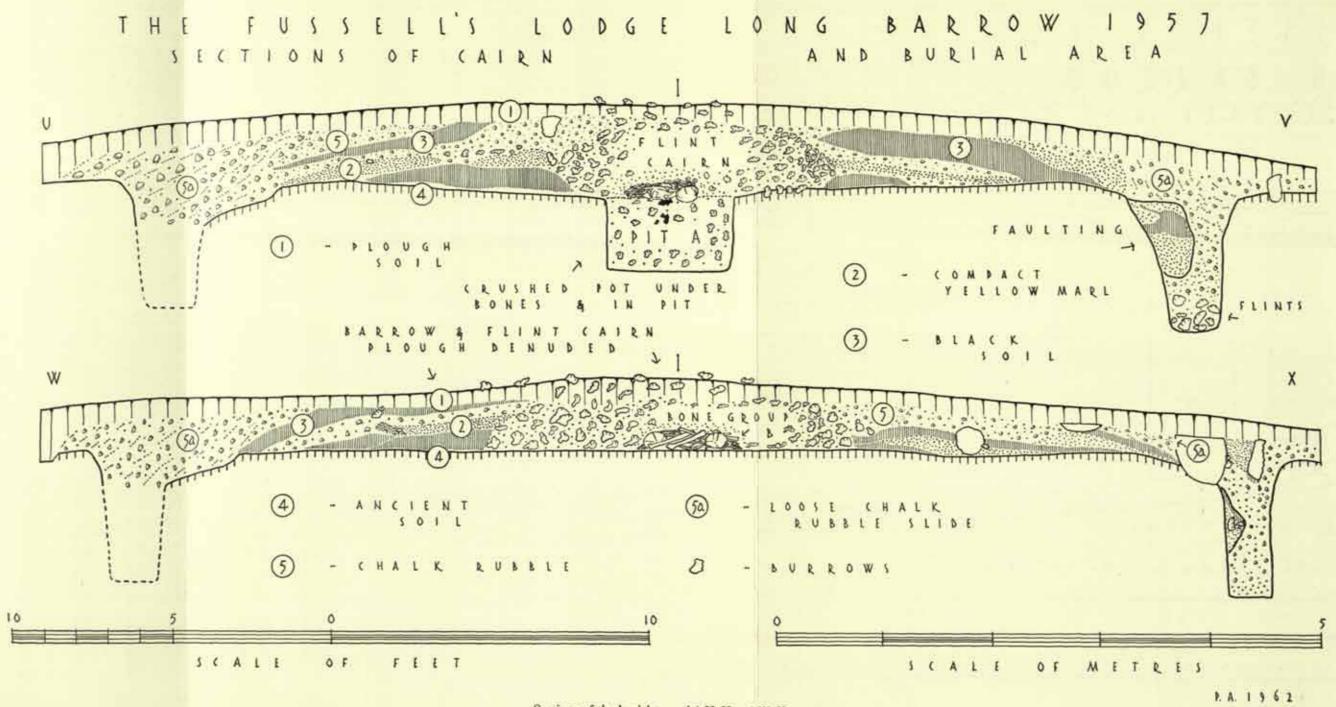
Sections of the burial area: (a) U-V and W-X

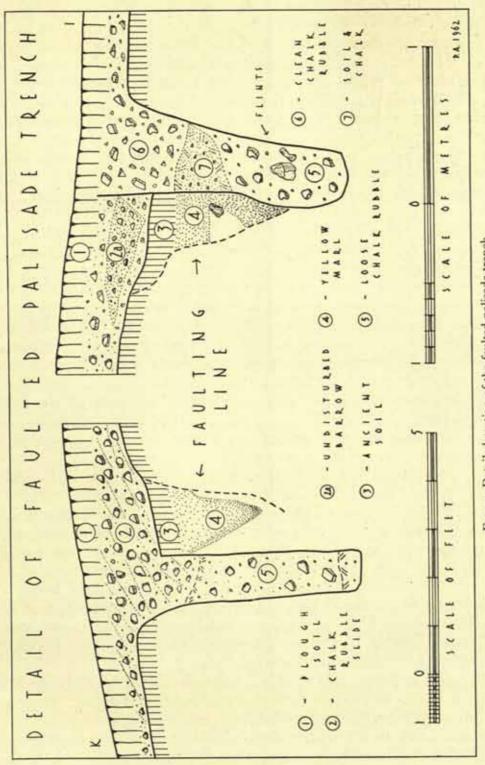
Fig. 3. Detailed section of the faulted palisade trench

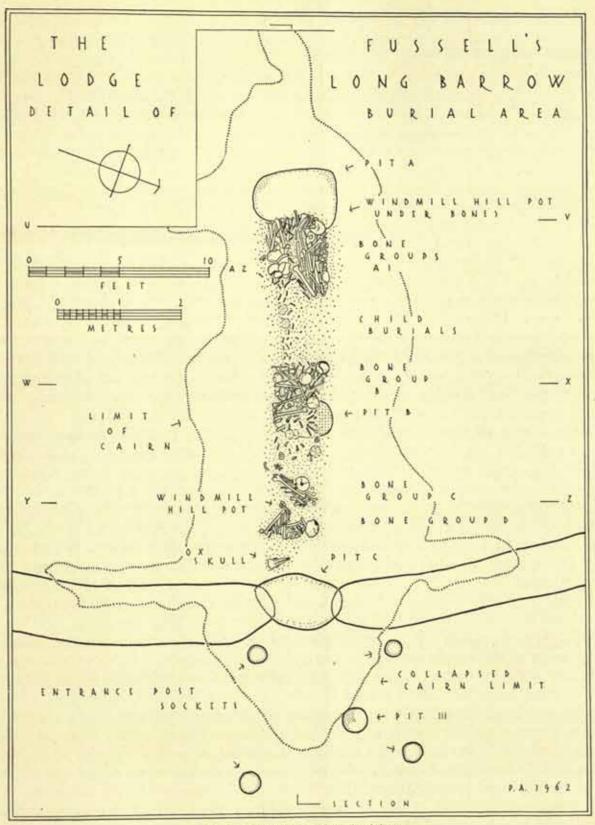
Fig. 4. Detailed plan of the burial area

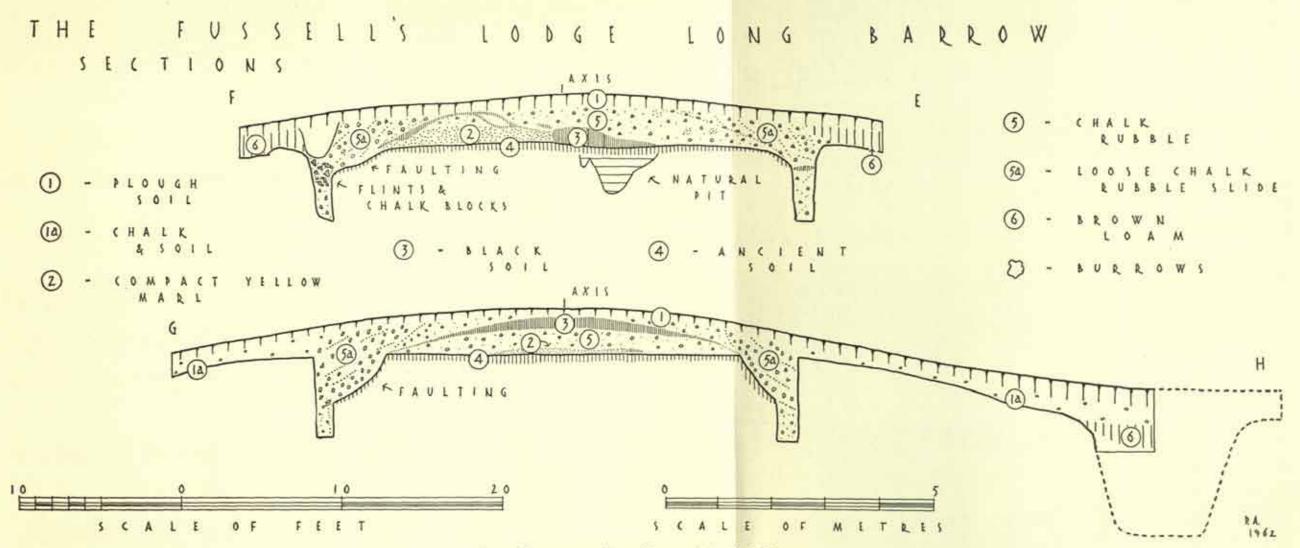
Transverse sections of barrow: E-F and G-H

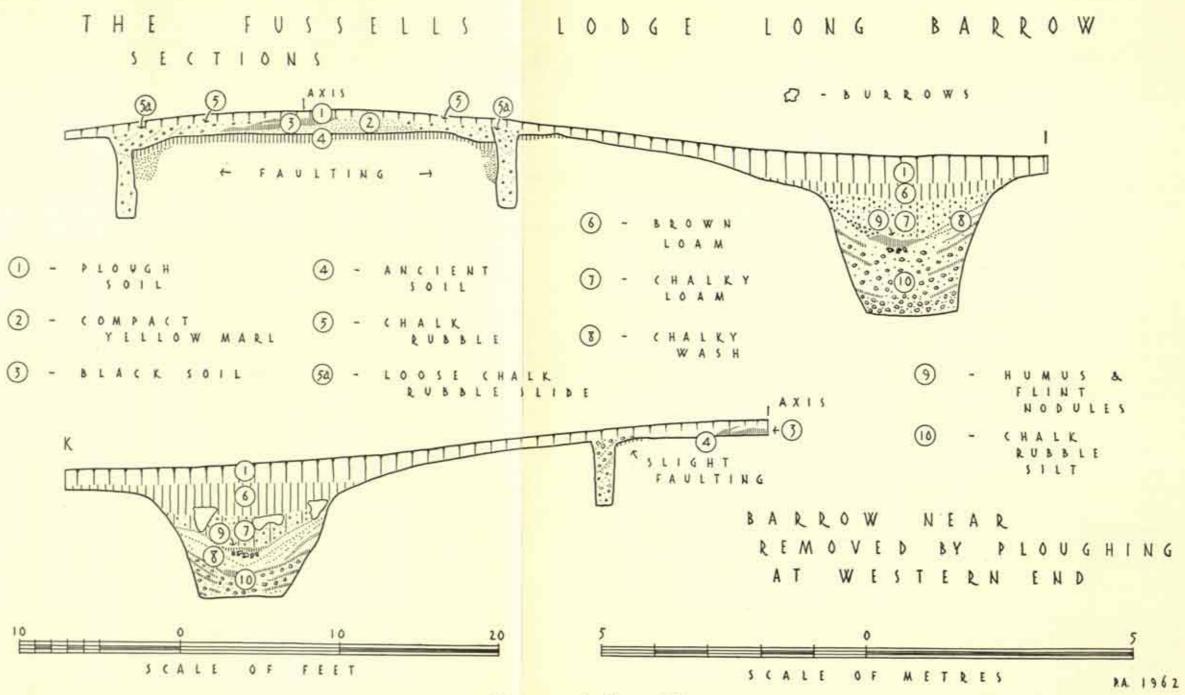
Transverse section of barrow: I-K

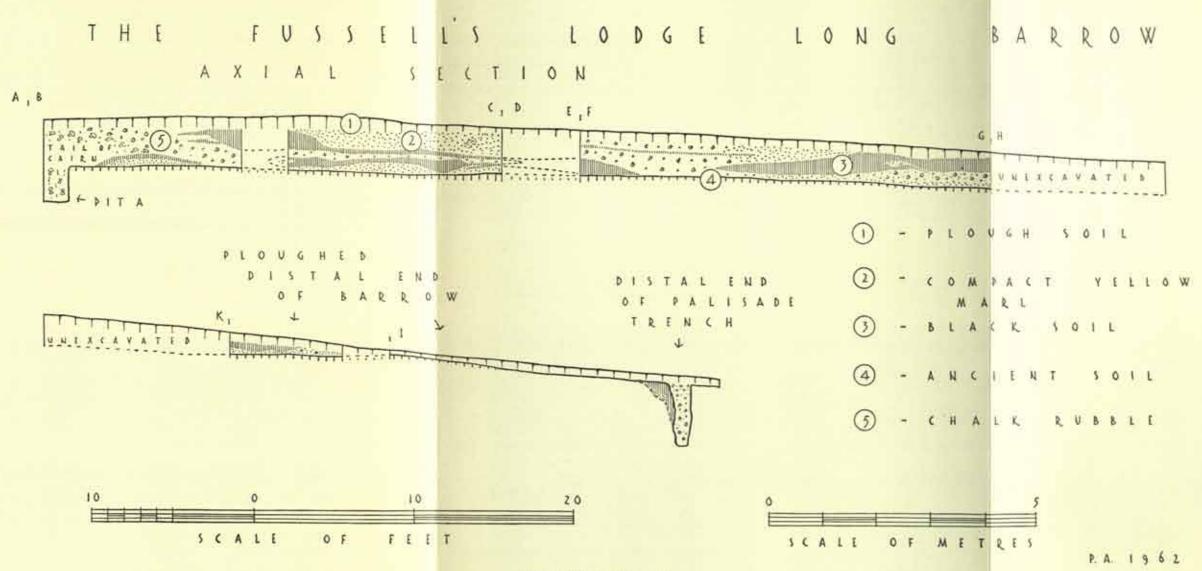
Axial section of the barrow

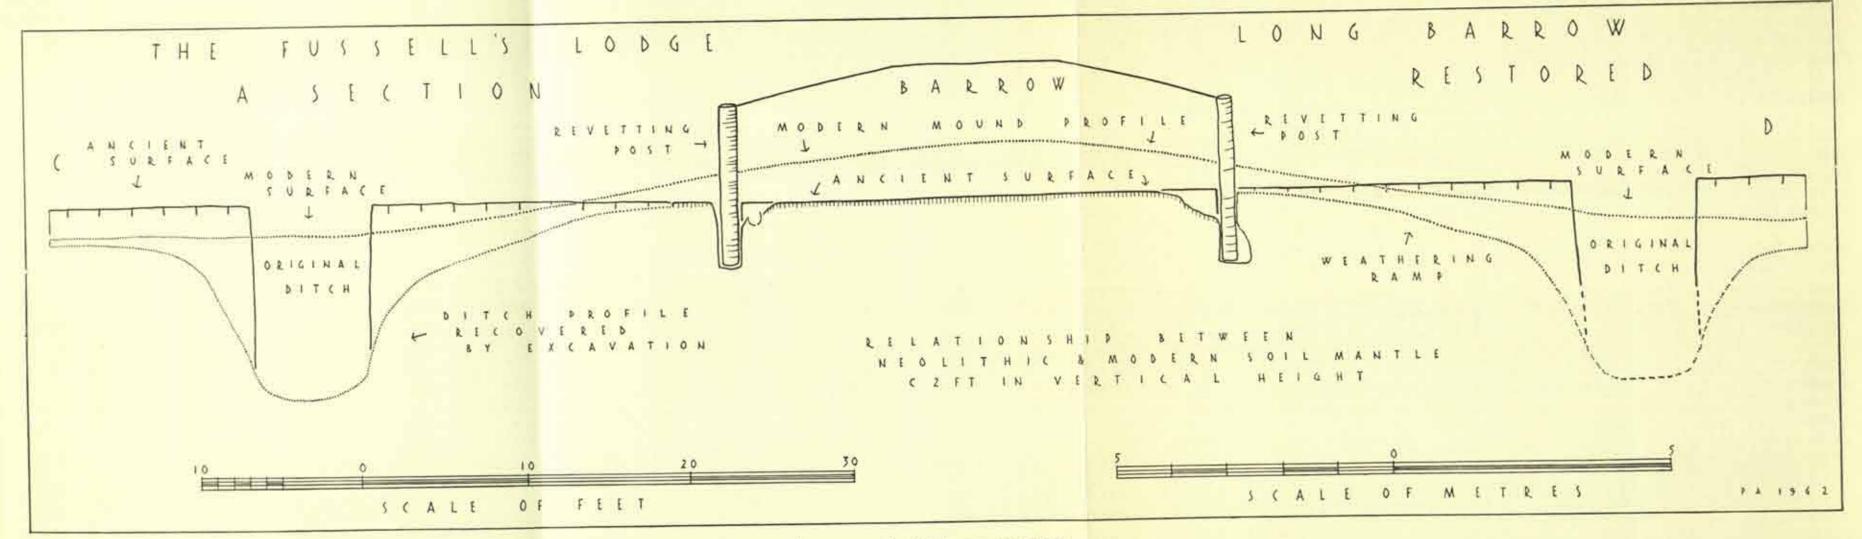
A transverse section of the barrow restored: C-D

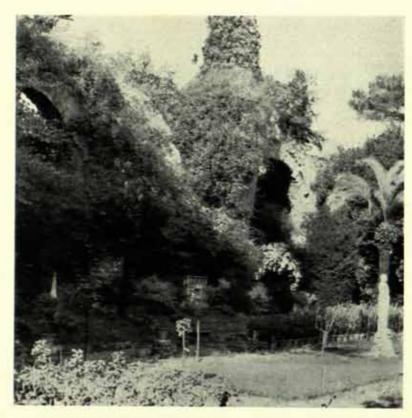
a. Bays 29 to 32 of the aqueduct as seen from the Embassy garden before repair. October 1956

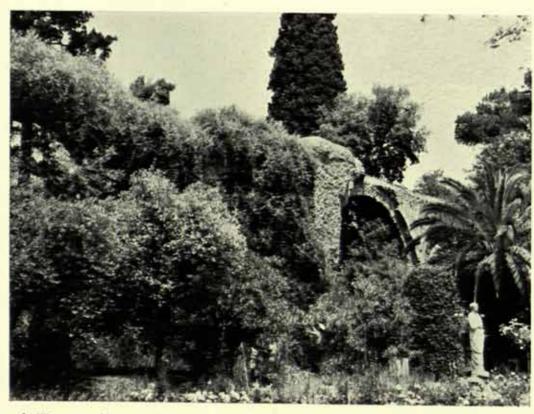
b. The same view as a (above) after repair. Taken in July 1960. The whole of the structure has been thoroughly consolidated beneath the vegetation

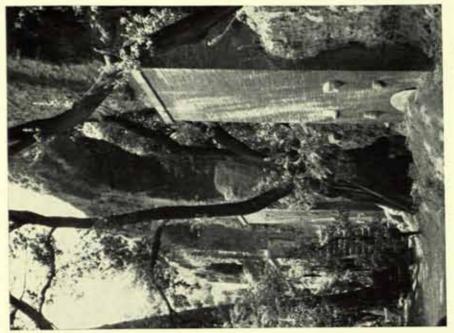
b. Bays 33 and 34 after repair and the removal of the most dangerous of the trees. Those rooted in the structure still remain and the late brick-facing to the piers has been left in position

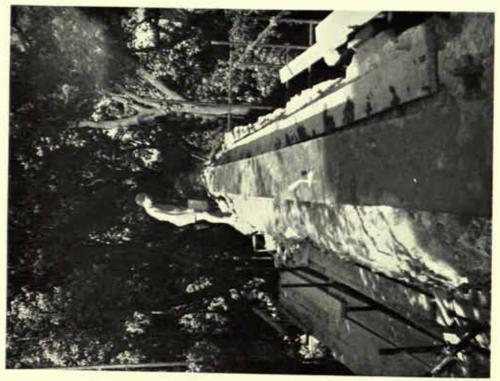
b. The reinforced concrete beam being cast in position above Bays 32 and 33. This was later concealed by the replacement of the floor of the duct where it existed or by corework

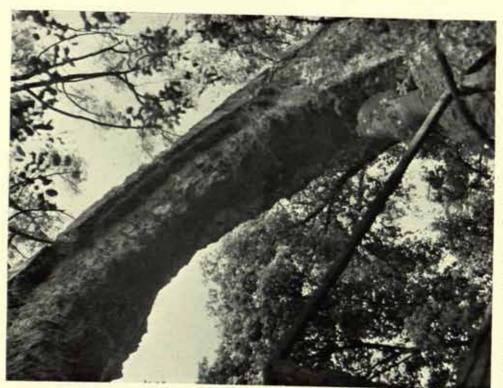
a. All that remained of the arch to Bay 33. Only the core is left and this was supported from a reinforced concrete beam concealed in the arch-top

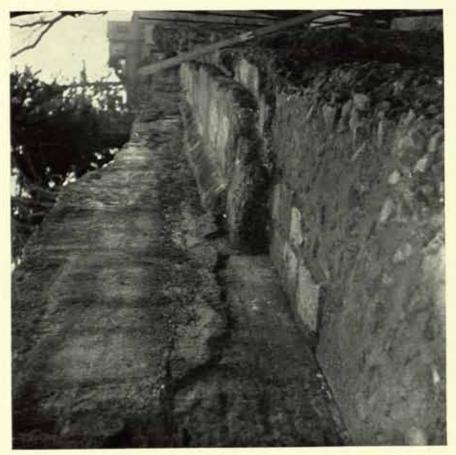
a. Detail of the water-channel floor above Bay 29. Note the plaster rendering to the duct walls, the benching of the duct floor which is seen here in end-section, and the tiled base upon which the floor is laid. View after repair

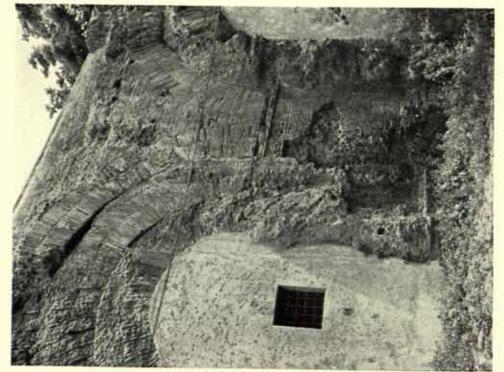
b. North side of Bays 13 and 14 with the pier, showing the remains of buttresses after repair. Note arches of three periods in Bay 14

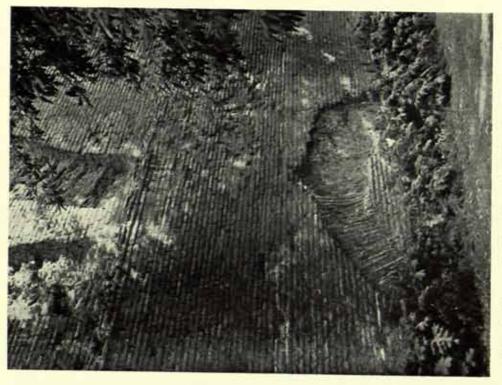
a. A detail of the north side of pier 15/16, showing Severan refacing, and relieving arch across the pier

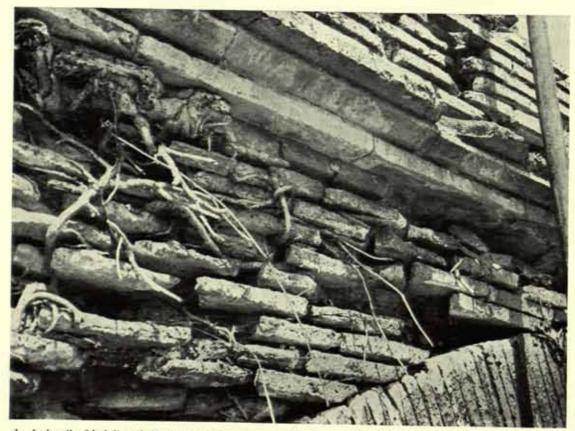
b. A detail of brickwork in the spandril of pier 7/8 before repair. Note the root growth beneath the main cornice and the complete absence of mortar from the facework

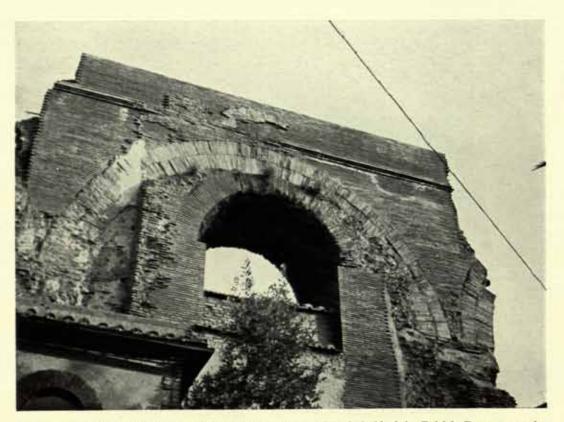
b. A view of Bay 2 similar to a after it had been repaired on behalf of the British Government by the Italian authorities. Note modern facework set back behind the line of the original face on the side of the water-channel

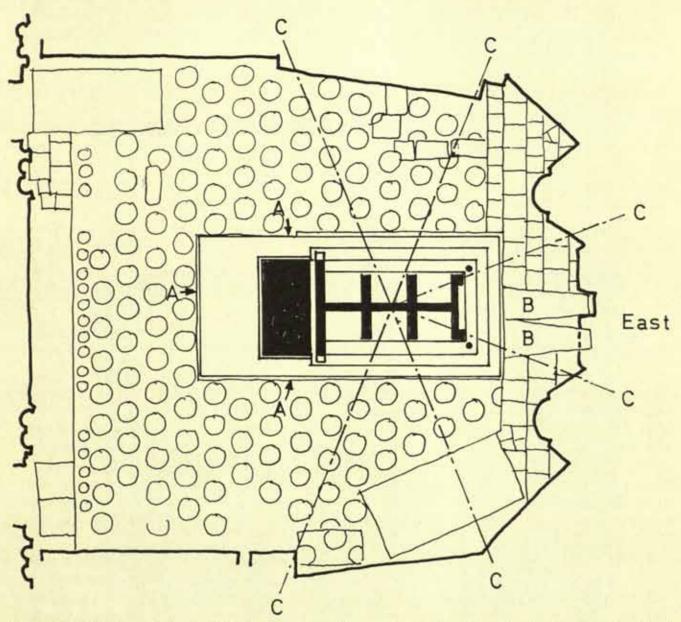
Fig. 2. Plan of Confessor's chapel with shrine in rearranged form, raised on four steps. The steps formed on the N., S., and E. sides are all the same size and touch the edge of the Cosmati floor (A) and the Valence tombs (B). The radiating point of the apse vaulting ribs (c) then occurs over the central point of the shrine

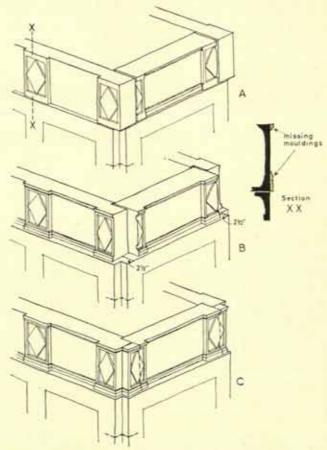
Fig. 6. View of SE, angle at upper side slab level. A—slabs as now: B—as it would appear after changing the slabs over from north and south, adding the missing mouldings, and placing the west ends of the slabs against the back of the reredos. The 2½ in. is as shown on figs. 4c and 5c. c is as B above but with the blocks on the east slab completed

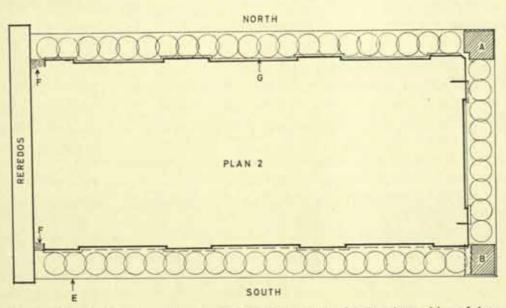
Fig. 9. Plans looking down through the inscription course showing the position of the upper slab course below it. Plan 1 shows the slabs in their rearranged position when the north side would not overlap the circle pattern on the soffits of the inscription course. The width of the end blocks of the upper slab course is given in inches. Plan 2. As existing, showing the partial masking of the circle patterns on the north side. (A and B) existing capitals; (C and D) ends of new portion of upper slab course; (E) edge of inscription course; (F) cement fill between end of slabs and reredos; (G) line of top moulding. On plan 2 the moulding is dotted where missing. On plan 1 the dotted line represents the joints in the stonework

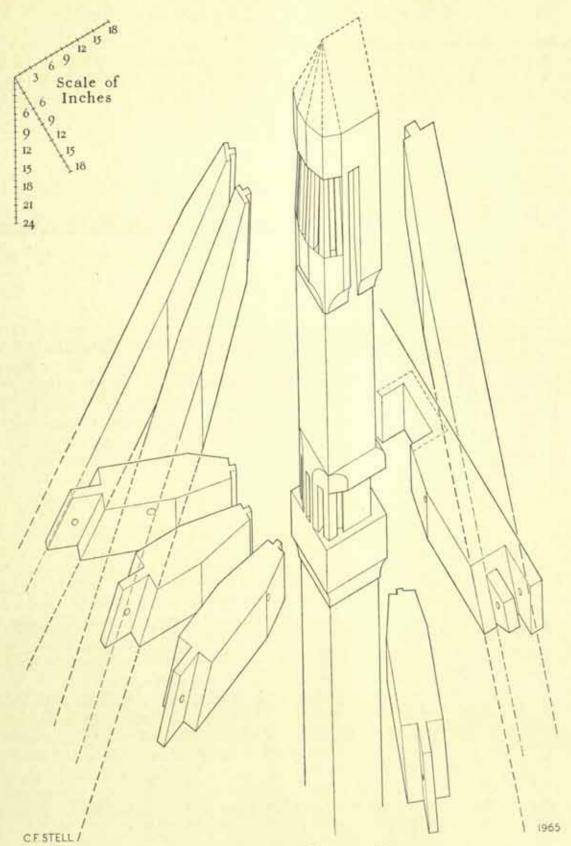
Fig. 3. King-post in Frame no. 28
