Conservation and Restoration of Angkor Wat and Ta Prohm Temple, Siem Reap, Cambodia

Devender S. Sood

Conservation and Restoration of Ta Prohm Temple, Siem Reap, Cambodia

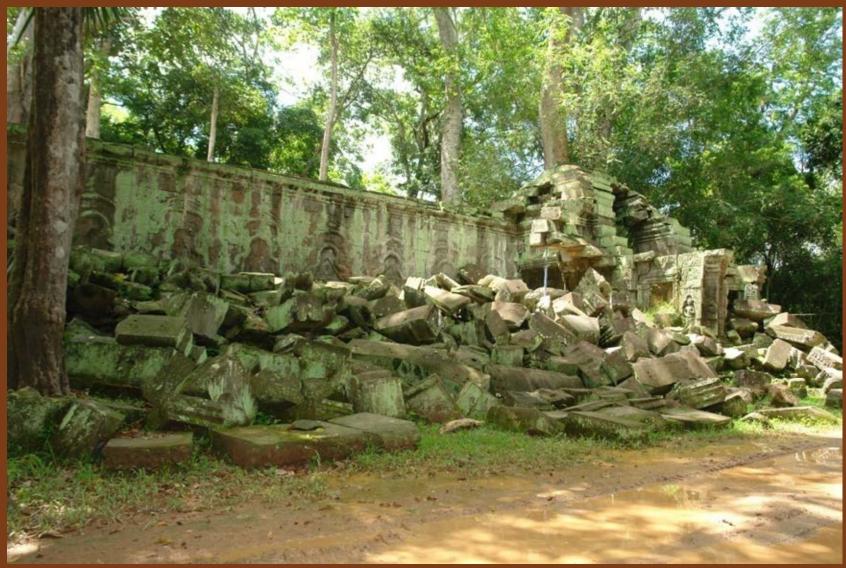
Collapsed third Enclosures Gallery on North East, Ta- Prohm, Temple

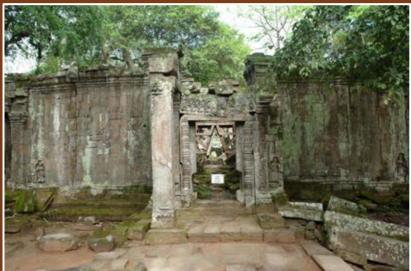
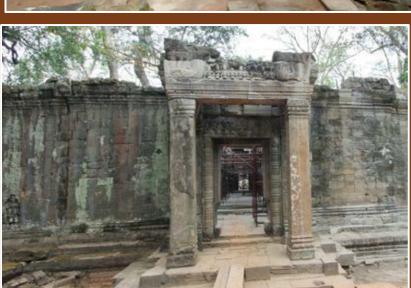
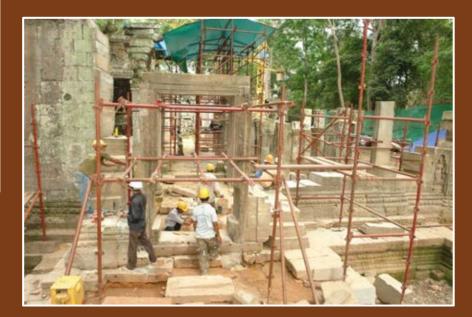
Eastern Entrance, Hall of Dancers

Before-2010

During-2011-12

During-2013-14

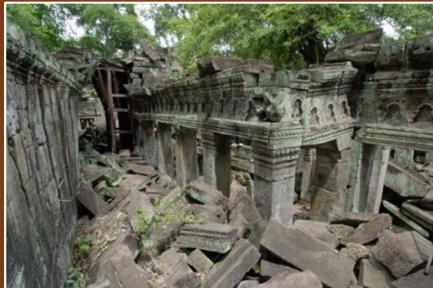
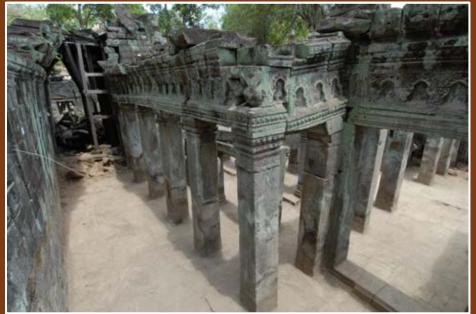
Interior elevation before and after removal of fallen stones

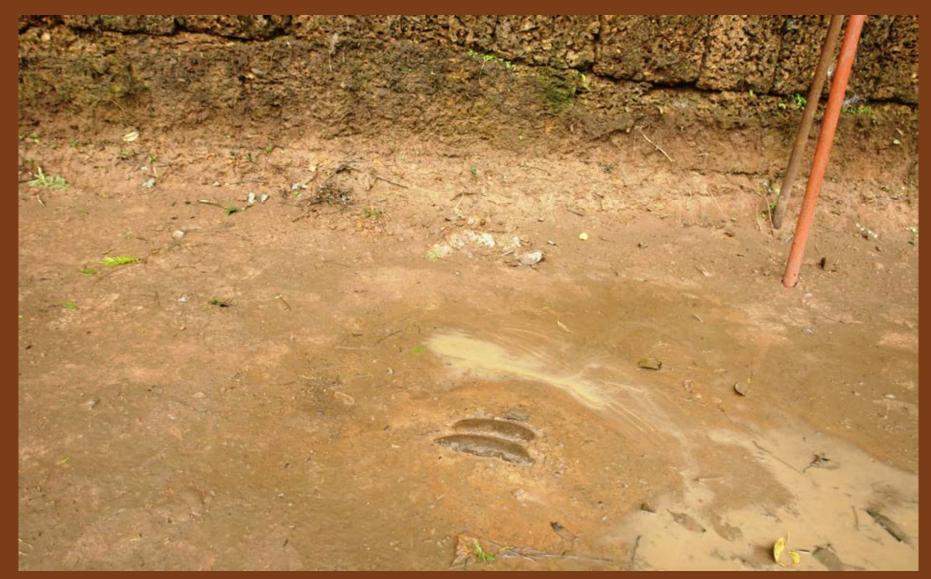
Buddha statue surface exposed after heavy rains near laterite wall.

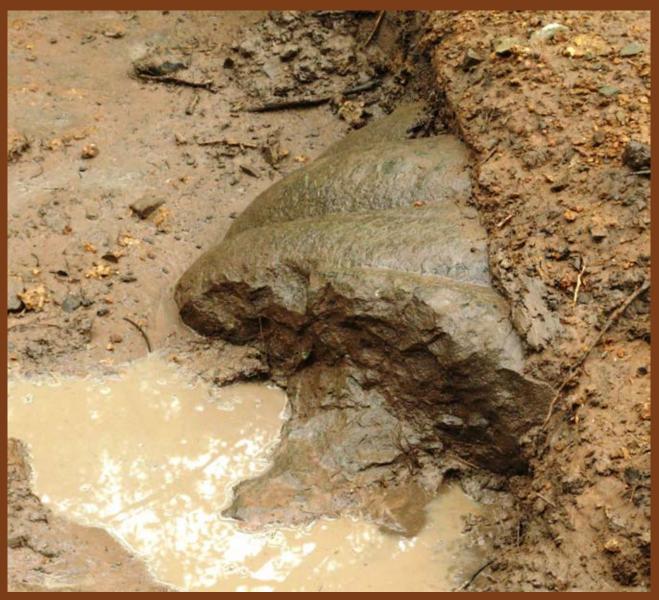
Buddha statue (Big size) exposed after heavy rains

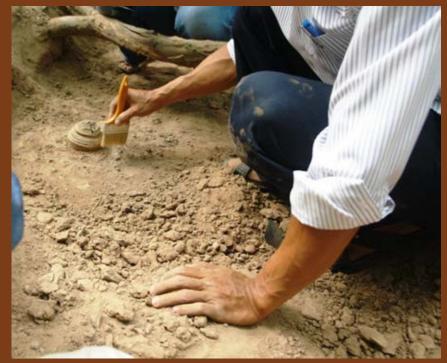
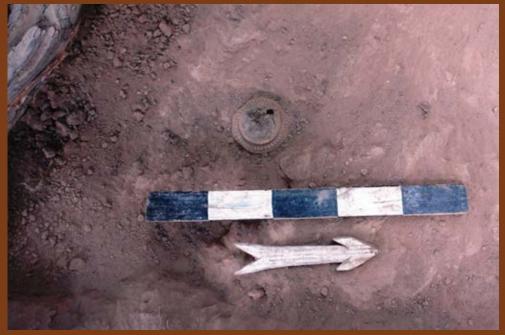
Visibility part of golden crown - After removal of second layer silt from the laterite floor.

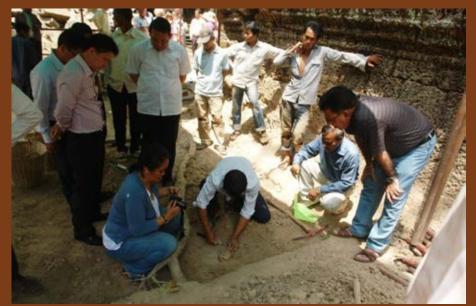
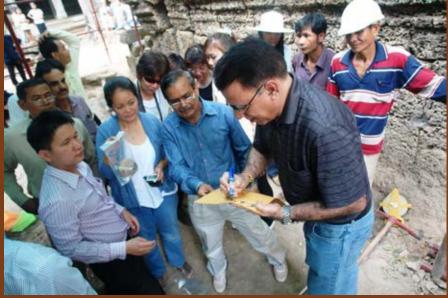
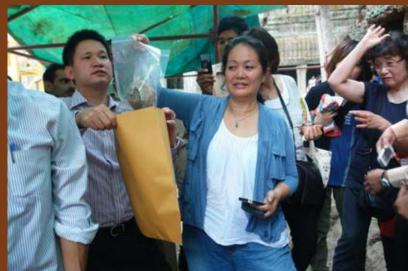
Recovery part of golden crown from deposit silt - In presence of HE. R.K.Sachdeva, Ambassador of India and APSARA officials.

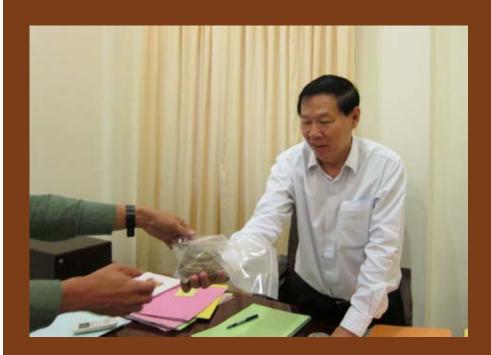
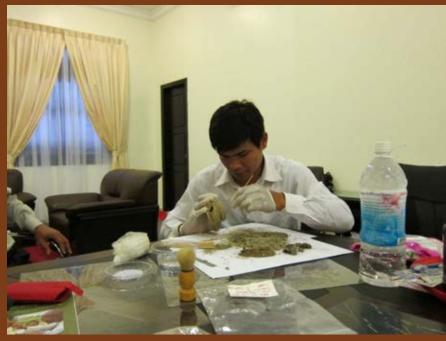
Part of the golden crown - Cleaning process in APSARA office. In presence of HE. Bun Raith, D.G. APSARA Authority

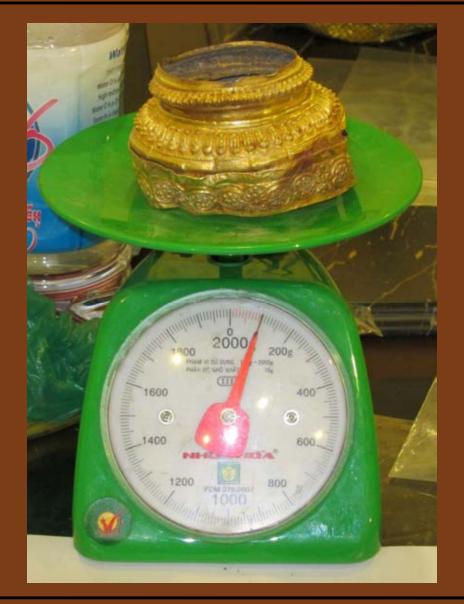
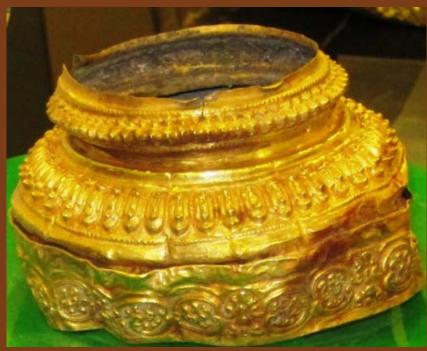
Part of golden Crown - After cleaning with weight

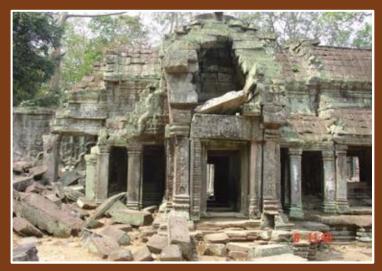
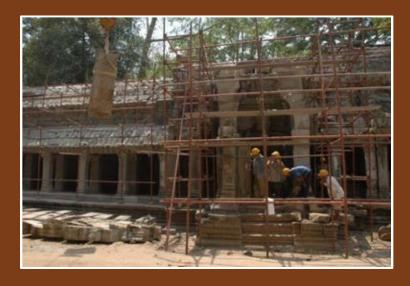
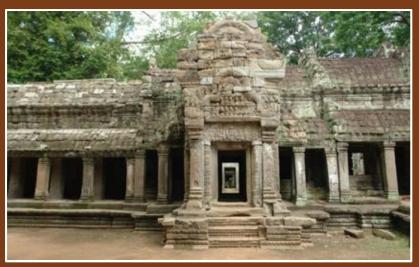
Third Enclosure Gallery, Eastern side South wing

Pre-Conservation

During Conservation

After Conservation

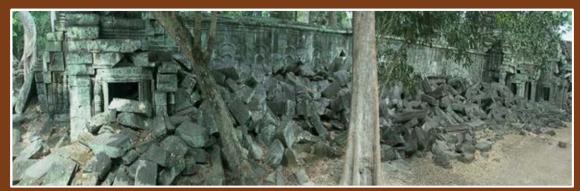
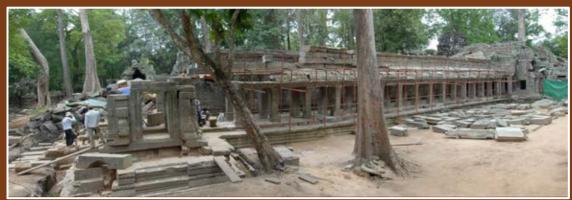
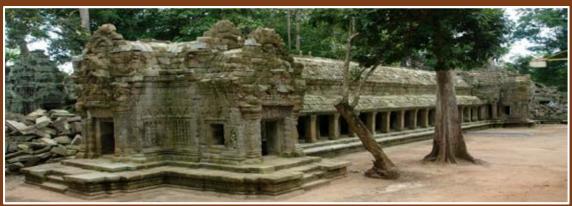
Third Enclosure Gallery, Eastern side South wing

Pre-Conservation

During Conservation

After Conservation

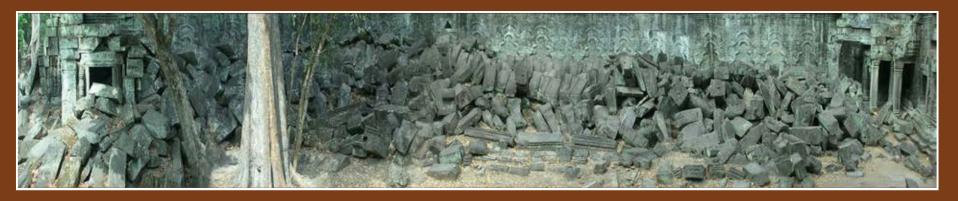
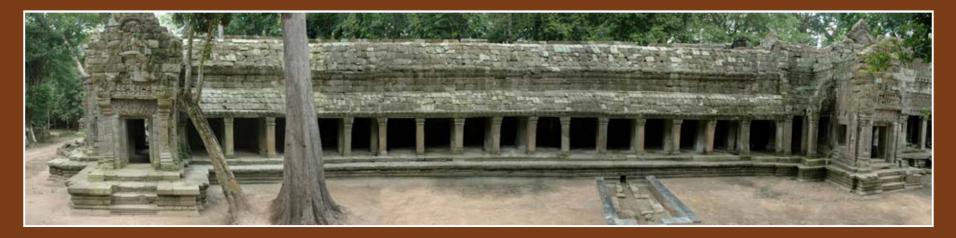
Third Enclosure Gallery, Eastern side South wing

Pre-Conservation

After Conservation

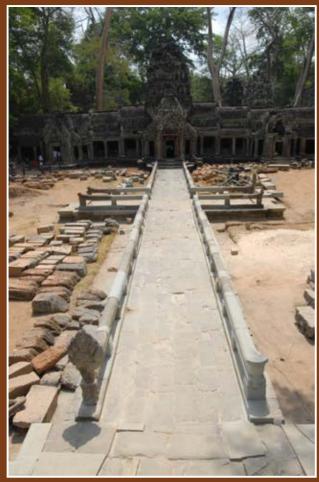
Causeway connecting 3rd and 4th Enclosure West

Pre-Conservation

During Conservation

After Conservation

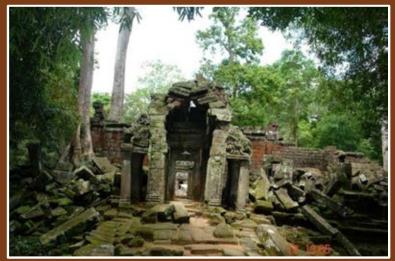
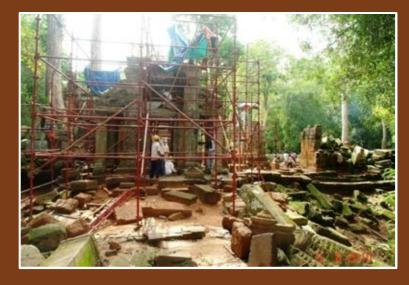
Entrance Gopurum of 4th Enclosure West

Pre-Conservation

During Conservation

After Conservation

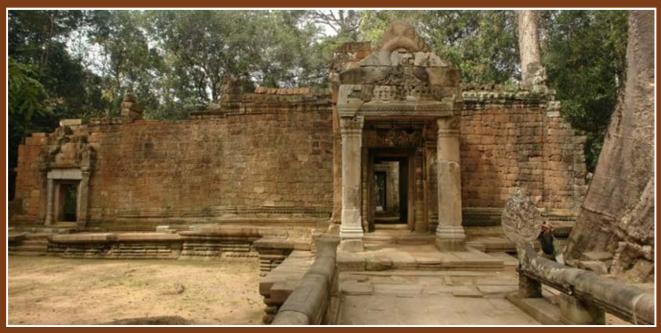
Entrance Gopurum of 4th Enclosure West

Pre-Conservation

During Conservation

After Conservation

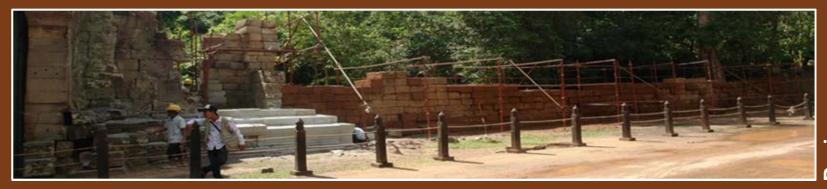
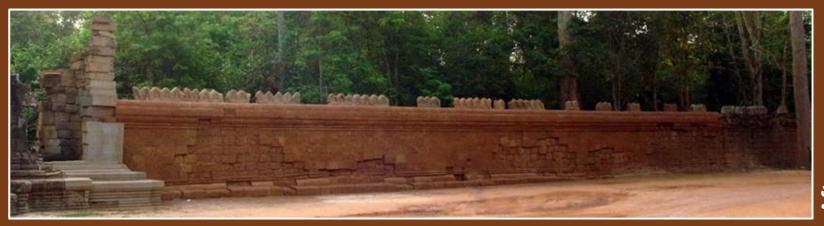
Laterite Enclosure Wall - Entrance Gopurum of 5th Enclosure West

Pre Conservation

During Conservation

After Conservation

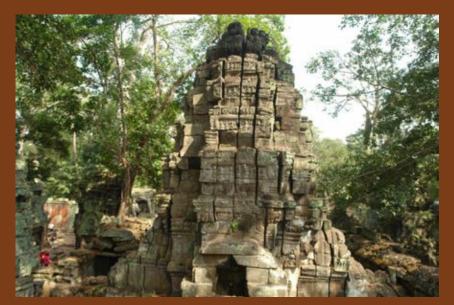
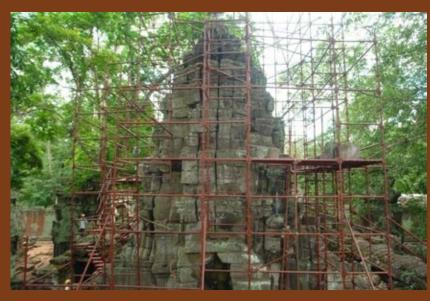
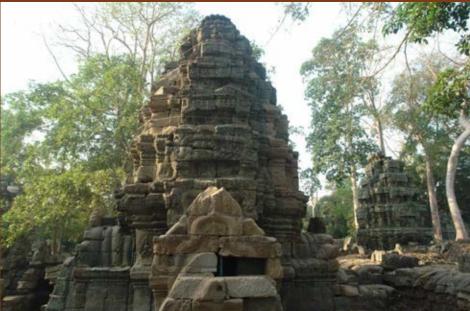
Tower along central axis (Location no.3)

Before

During

After

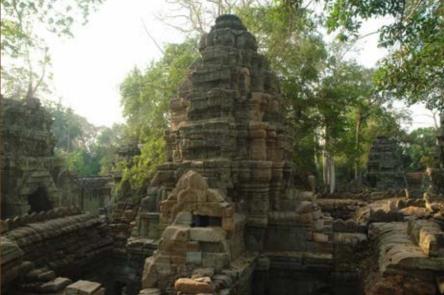
Tower along central axis (Location no.3)

Before

During

After

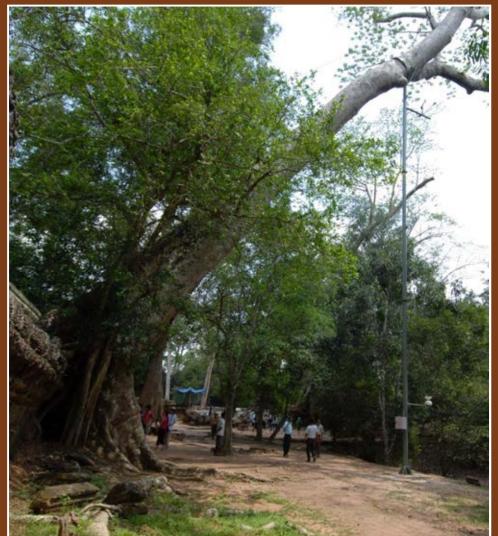
Tree Support along with weather station

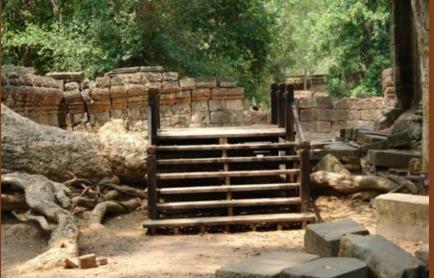
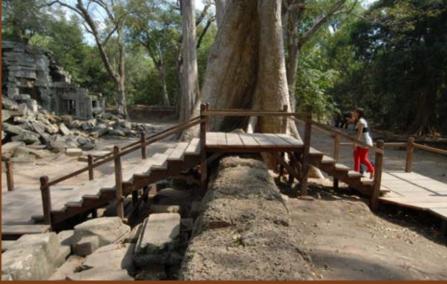
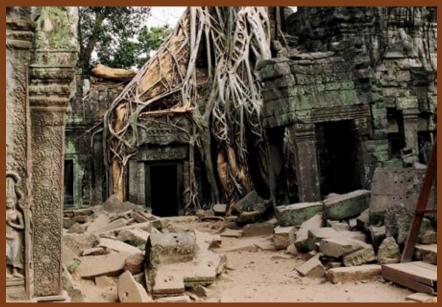
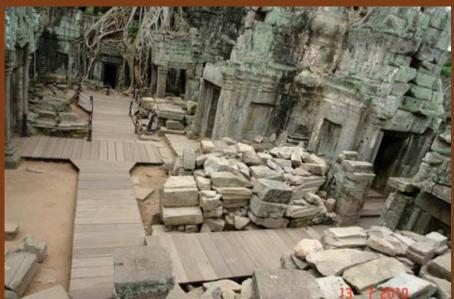
Wooden Walkways

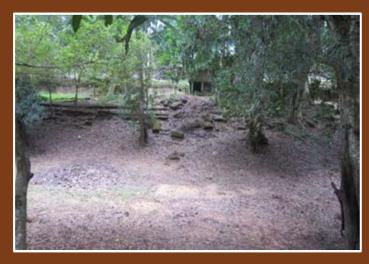
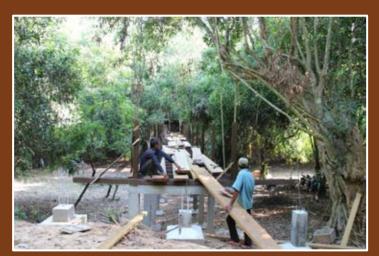
Before

During

Construction of bye pass bridge for exit from south
